Coastal Hazard, Risk, Management and Adaptation Plan (CHRMAP)

The City of Albany has recently received funding from the Department of Planning to complete a CHRMAP for the project area. This process will take 2 years to complete. The purpose of this work is to consider a full range of planning instruments in order to plan for the short and long term management of the coast. It will be done in six stages and will involve extensive community engagement.

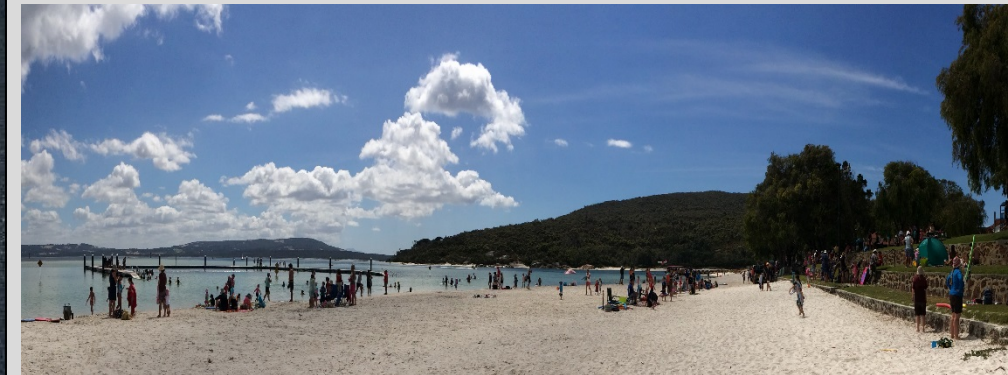
Start: December 2013
Since December 2013 Acoustic Water and Current Devices (AWAC) have been deployed to collect wave and current data. This data was used for recent modelling work for the Coastal Vulnerability and Hazard Mapping study. A data gap identified by this modelling means that an AWAC will soon be deployed off Emu Point to capture data on wind driven currents.

Start: April 2014 - ongoing
In autumn 2014 two trial sand bag groynes were constructed at the western end of the revetment and nourished with 10,000m³ of sand. Results show that local erosion in this area has stabilised. In autumn 2016 and 2017 a small addition of sand bags were added to the groynes to maintain their structural integrity. Sand nourishment will be carried out to this area as required.

Start: January 2014-ongoing
In early 2014 an Anemometer was installed atop the Albany Port Authorities' navigation beacon at Emu Beach. This instrument measures wind speed, direction and gusts and provides localised data. Live wind data is available for viewing on the City of Albany website. This is managed by Ecotech Pty Ltd.

Start: Sept 2014-ongoing
In September 2014 a tide gauge was installed by DoT at the Emu Point Boat Pens. The aim of recording water levels in Oyster Harbour is to establish the effect of the narrow entrance on the water levels in Oyster Harbour during normal tidal conditions and in storm events. This instrument is supplied and managed by DoT.

Start: Oct 2014 - ongoing
In October 2014 a fixed time lapse camera was installed at the western end of the rock revetment. This camera takes an image every half hour and these images are compiled into a time series video. This is managed by BMT Oceanica.
