Council Management Plan

Archaeological Survey and Monitoring of Site Work. Plantagenet Battery Restoration Project, Albany WA

February 1999

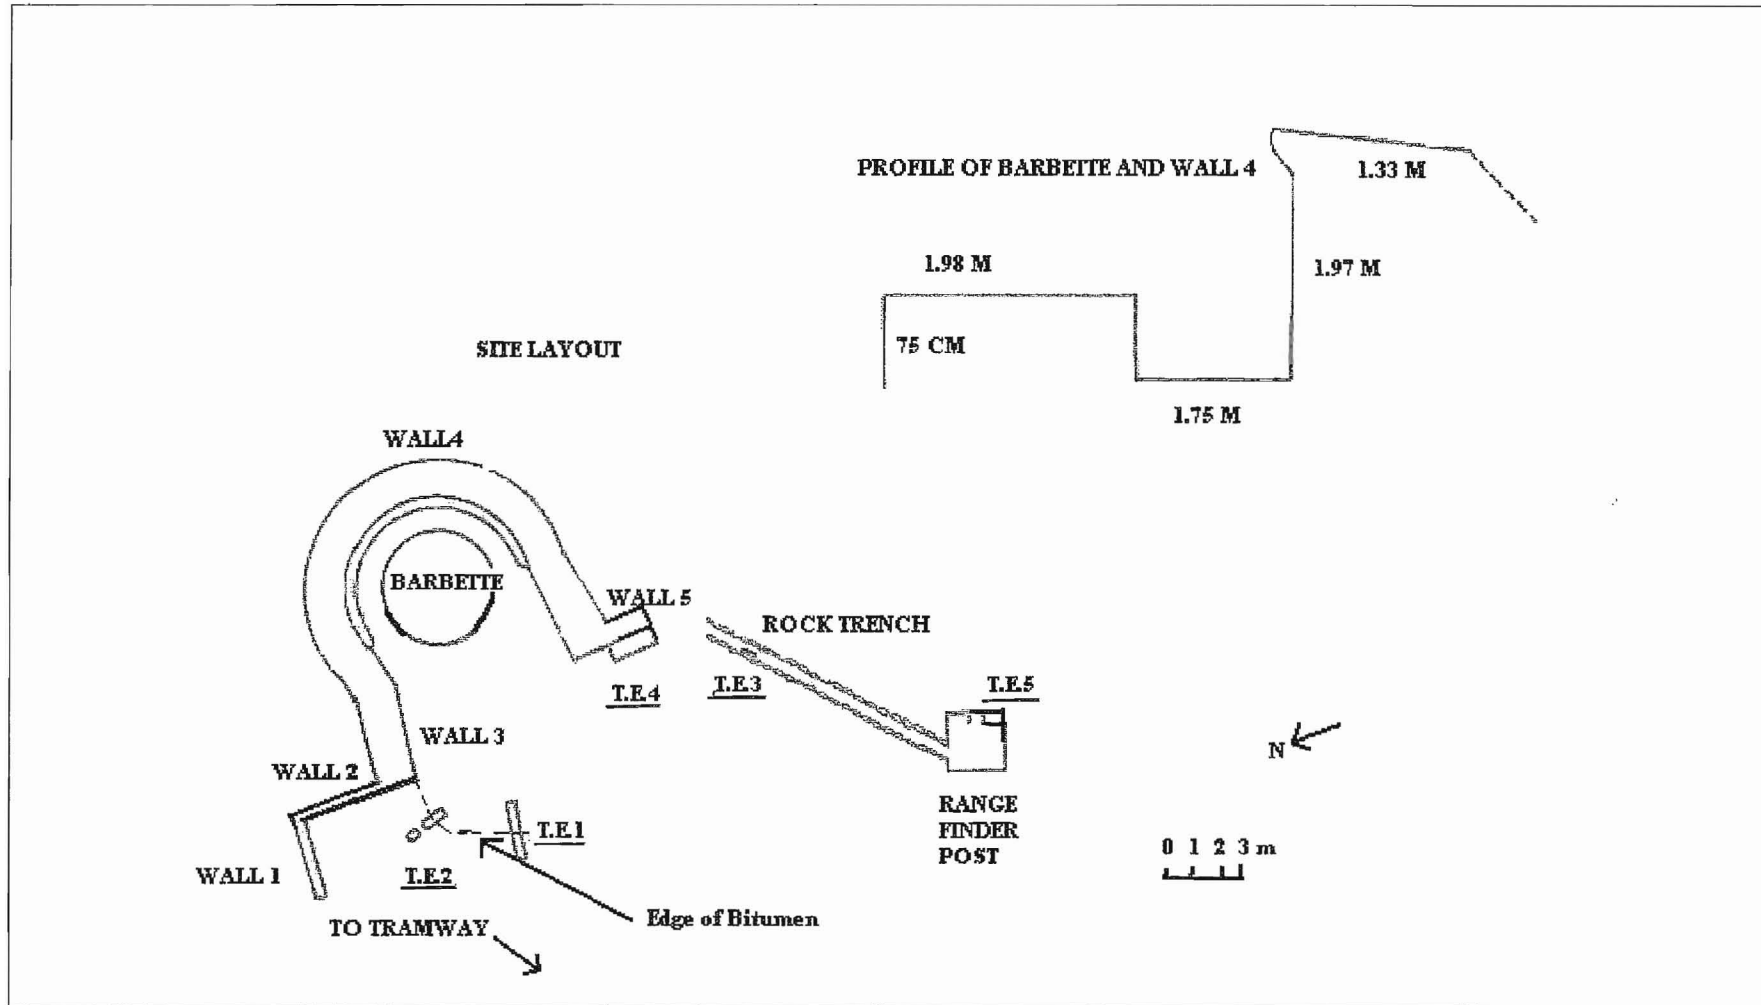
FIGURE 2 SITE PLAN

The vegetation was cleared from the emplacement allowing details to be recorded (Plate 2). The battery was oriented so that the guns pointed east overlooking Point King and the entrance of Princess Royal Harbour. This means the emplacement lay on a north to south line (Fig 2). The main features of the emplacement were concrete form work with the use of wood and metal being mainly confined to doors hinges and screw bolts. Several surfaces had been defaced with graffiti, which has been both painted and scratched onto the walls.

At the northern end of the battery, walls 1 and 2 formed two sides of a lean to shed (Fig 2 & Plate 3). Wall 1 sloped in height from south to north. It partly supported a corrugated iron roof the end of which was embedded into the concrete of the wall (For close up details please see photo archive). The corrugated iron extended along the top of the wall to a point, which was approximately one meter above present ground height. Marks on wall 1 indicated that a wooden post had been placed against the wall at this point to support the lower edge of the roof (Fig 3 & Plate 3). A wooden roof beam had also been laid in concrete along the top of wall 2 forming the upper end of the roof. ②

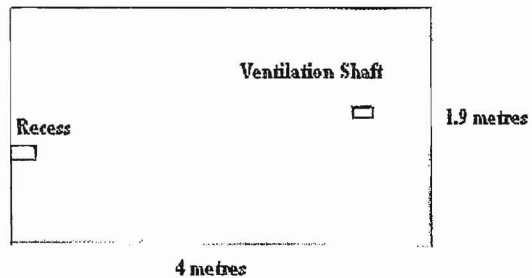
FIGURE 4. WALL 2, ELEVATION

A rectangular recess in wall 1 once supported a beam as did a similar recess in the corner of wall 2. A second recess in wall 2 was actually a ventilation shaft for the shell storage unit in wall 3 (Fig 4).

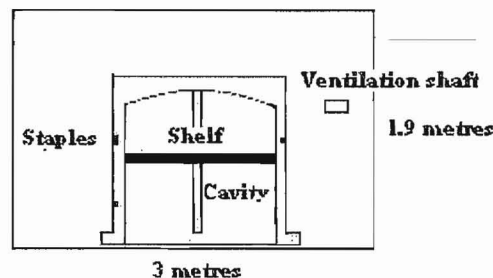
FIGURE 5. WALL 3, ELEVATION

Wall 3 faced south west and contained a shell storage unit (Fig 2 & Plate 4). The horizontal wooden rack within the unit was in good condition (Fig. 5) however the wooden slats which should have lined the walls of the unit and the vertical beam in the center of the back wall were missing. Patches of red paint still exist on the wooden racks and on the lower half of the door recess.

4. Expert advice should be sought on whether the existing woodwork on the gun battery can be conserved and left *in situ*.

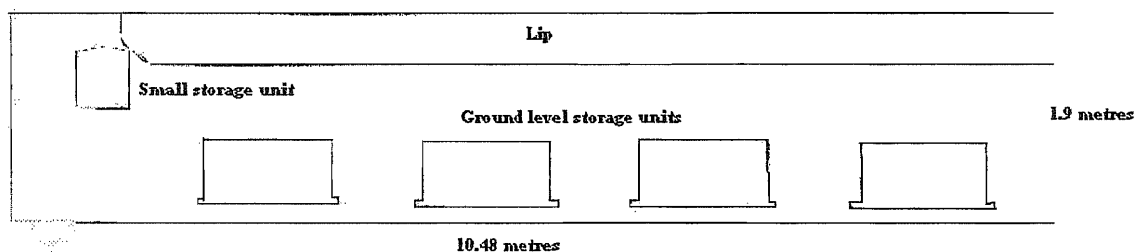
FIGURE 6. WALL 4, NORTHERN PORTION, ELEVATION

Each of the floor level storage units once had a wooden plank as a base. The plank slotted into the bottom of the unit via a built in recess on either side (Fig. 6 & Plate 8). The two most northern units and the one to the south still had the wood *in situ*. The central two units appear to have been exposed to more weathering and the wood has rotted away. The restored gun battery at Albany Forts (Plate 6) indicates these storage units had no other built in furnishings.

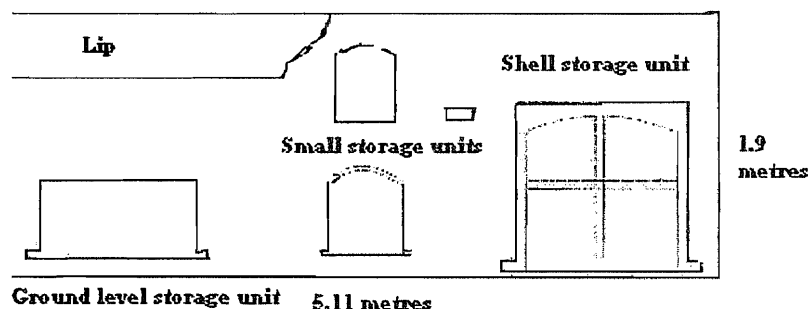
FIGURE 7. WALL 4, SOUTHERN PORTION, ELEVATION

Two identical small arched units were located in the same position at the northern and southern ends of wall 4 with an overhanging lip along the inside of the wall between them. A slightly larger unit was located immediately underneath the southern unit (Fig. 7 & Plate 7). They were all similar with a door recess and with the larger unit also having a slotted recess at the bottom for a doorsill. None still had the wood *in situ* although traces of render remained in all three. The larger unit had beige render over the pale cream and wooden studs in the back wall. These were probably for a shelf as shown in a similar restored unit at Albany Forts (Plate 9). However, that in the Plantagenet gun battery did not have an air vent.

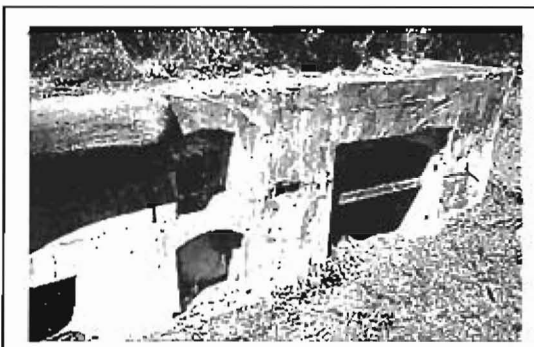
PLATE 7 WALL 4, SOUTHERN END

Wall 4 formed a half circle enclosing the barrette, over which the gun would have been fired, as shown in Plate 6. It contained five floor level storage units, three small arched units and a unit similar to the one in wall 3 (Plate 7, for more detail see photo archive). The inner surface of the recesses, which were protected from weathering, still had a lining of pale cream lime render. No evidence was found that signs had ever been pinned to the wall.

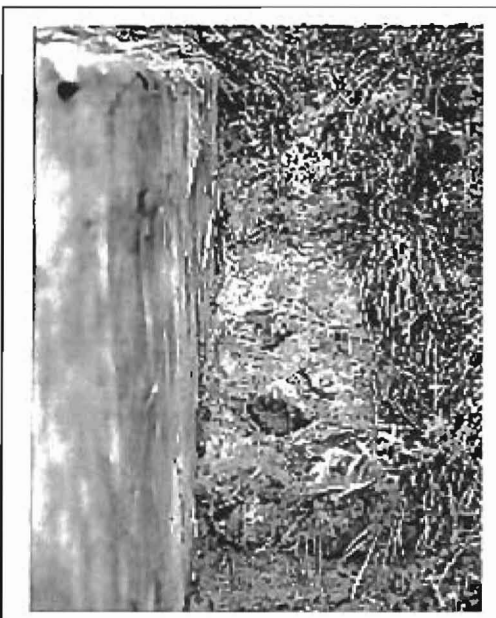
PLATE 10 TEST EXCAVATION 4

Test excavation 4 was excavated beside the southern end of wall 5 to locate any evidence of steps allowing access to the range finder post located further to the south. The pit was excavated as a trench 40 cm wide and just over a meter in length. The depth excavated varied along the length of the excavation in response to present and past ground level changes. Evidence was found of a stone retaining wall with rough step like changes in elevation (Plate 10). There was no direct evidence for wooden steps but the stonework is much more likely to have been constructed as foundations for wooden steps than as actual steps. Artifacts recovered during the excavation consisted only of relatively recent bottle glass, which was on the surface and not retained.

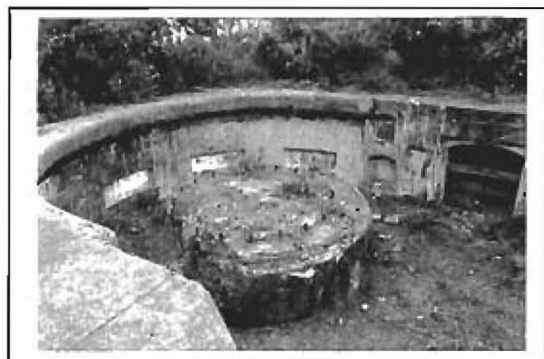
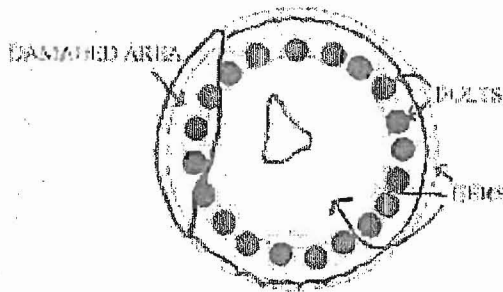
PLATE 11 BARBETTE

The barbette stands 75 centimetres high and has a diameter of 3 metres (Plate 11). The sides of the structure are perpendicular and the top surface has three tiers, which rise in height from the rim to the centre of the structure (Plate 11). At the junction of the second and third tiers is a ring of 20 steel bolts spaced 39 cm apart. These bolts once held the ring on which the gun turned. The ring has been blasted off the structure causing considerable damage. It is now located at the Albany Forts (Plate 12).

The outer rim of the barbette has been almost completely destroyed. The damaged area forms the outer tier on Figure 9. The central highest tier has also been much damaged with only a central portion remaining at the original height. However, the most damage has occurred along the northern edge of the barbette where all three tiers and the base beneath have been removed for a depth of 60 centimetres.

1. Expert advice should be sought on repairing the concrete form work on the barbette and removing graffiti from the form work.. In particular care is needed to ensure that concrete repairs do not chemically damage the remaining heritage fabric.

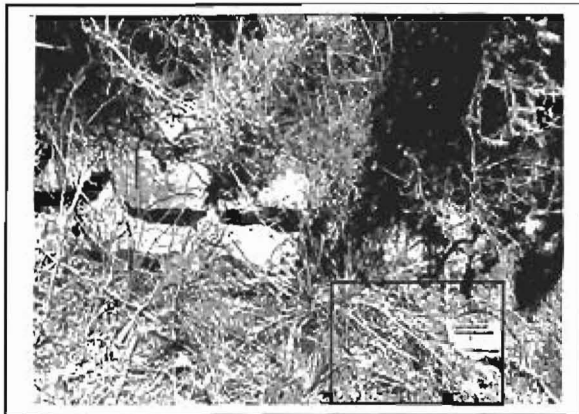
PLATE 13 ROCK TRENCH AND T.E.3

To the south of the gun battery a range finder post was located (Fig. 2). It was joined to the battery by a shallow rock lined trench, which started near the southern end of wall 5 (Plate 13). Test excavation 3 was located within the trench to determine the ground

height when the trench was in use. The rock wall at this point proved to be only 37 cm high (see Plate 13 for location of test excavation). The previous ground surface was not located at the bottom of the rock but 9 cm underneath where a 2 cm deep layer of pea gravel was located (Plate 14) and removed as spit 2. Pre 1920s (ca 1860-1920) glass was recovered both from immediately above and immediately below the pea gravel confirming that this feature was part of the short operational lifespan of the gun battery. The difference in height suggests the gravel path was laid first in a cutting dug into the sand and the rocks were a later innovation to keep the soft sand from caving in.

2. The rock lined trench to the range finder post, the floor of the lean to shed, the cleared area beyond it, the tramway track and the area immediately around the range finder post should not be cleared, beyond removing vegetation, without archaeological monitoring. These areas are all likely to contain features and artifacts such as evidence to indicate whether there was a roof over the range finder post and artifact layering relating to the use of the gun battery.

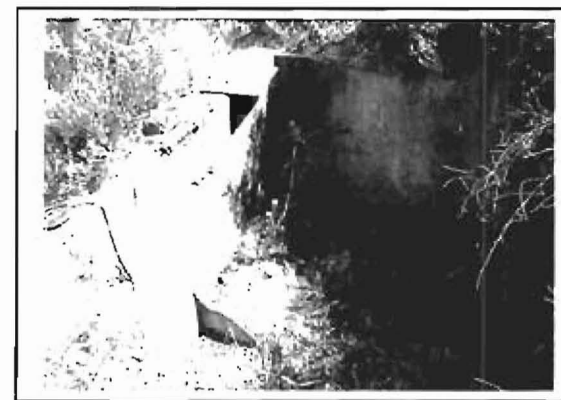
PLATE 15 RANGE FINDER POST

The range finder post was located 9.7 metres from the southern end of wall 5 with an entrance in its north east wall. It's walls were 1.8 metres long forming a square and 1.16 metres deep. It was constructed of concrete covered brickwork with a concrete floor, which sloped down to the southern corner. The bricks are moulded red bricks with a shallow rectangular frog. The post was orientated so that the south east wall overlooked the entrance to Princess Royal Harbour. The remains of fittings on the south east wall denote where the range finder was located (Plate 15). The remains consist of a partly broken lip surmounted by two iron hoops below which are marks where a fitting has been rendered against the wall. At the bottom of the wall the remains of two thin rendered side walls are still in evidence.

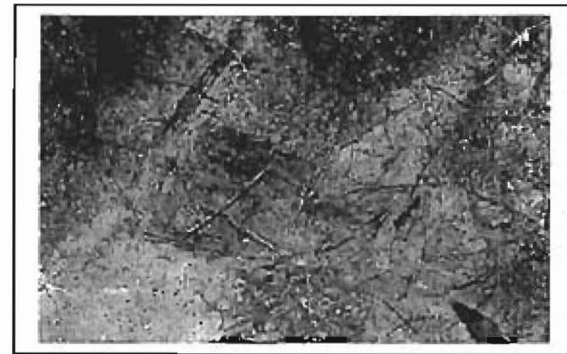
PLATE 18 TRAMWAY *IN SITU*

Test Excavation 6 was located in the lower cutting area approximately 12 metres from the start of the cutting. A wider area of vegetation was cleared to allow room for the excavation and a trench 3 metres long by 50 cm wide was excavated. Under 10 cm of leaf litter was a grey sand layer also approximately 10 cm thick. At the bottom of this layer sections of rail could be seen. The rails and the sleeper they were bolted to were actually embedded in a layer of yellow sand (Plate 18). The rails were 6-7 cm high (the variation is caused by deterioration) and 65 cm (2ft) apart and at this point they were orientated at an angle of 260 degrees. While still *in situ* the rails and sleepers are not in good condition.

2. The tramway track should not be opened up for assess without getting expert advice on the conservation implications of having intact rails and sleepers in poor condition only 10 cm under the present track surface. The tracks lie along one side of the cutting and it may be possible to direct pedestrians alongside them without impacting the heritage fabric.

3. Conservation advice should also be sought before any section of the track is uncovered for display purposes. If a display is decided on then the display area should be excavated by an historical archaeologist.

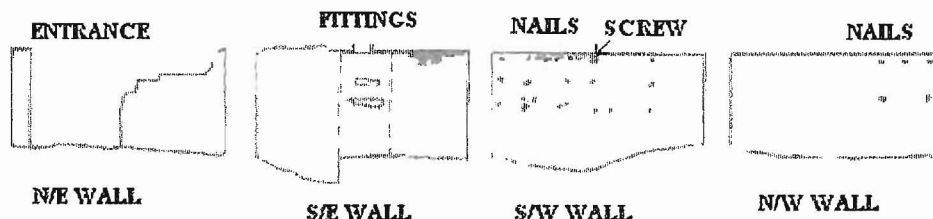
FIGURE 10 RANGE FINDER POST ELEVATIONS.

On the south west wall is a series of rhomboid headed wire nails of a type not available until 1895 (Fig. 10). There are two different sizes of the same nail type and a copper screw located in the wall. On the ground adjacent to the wall was metal sheeting and it appears the nails held the sheeting in place on the wall. While the sheeting currently shows no evidence of writing it is likely that it once contained the distances and elevations to different landmarks seen from the post.

The north west wall also shows evidence of attachments for signs. There are five rose headed wire nails arranged in a rectangle, four of which still had fragments of metal sheet attached. The nails were harder to positively identify without removal but they appear to be a nail type, which was available from ca 1880 to 1900.
