10. MONITORING PLAN

10.1 MONITORING PLAN

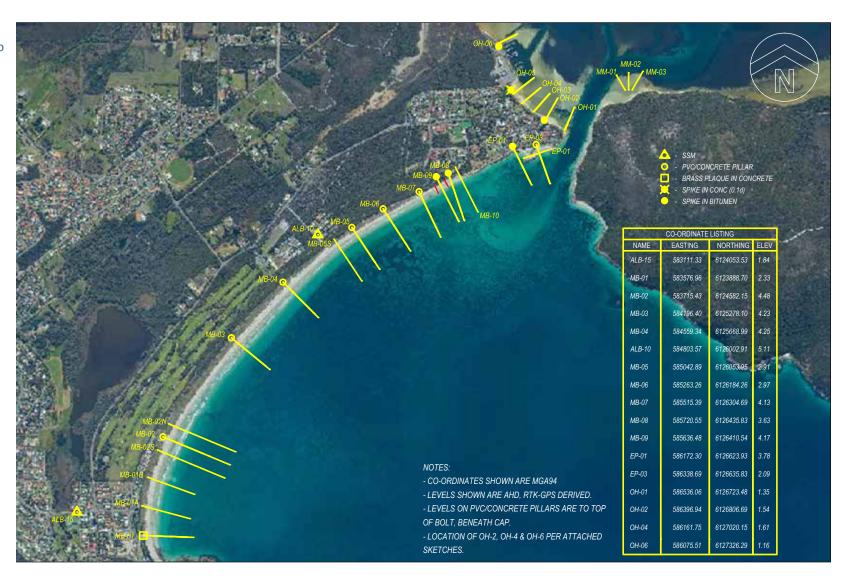
Figure 10.1 - Beach transects Ellen Cove to Oyster Harbour Beach

These are required to inform a number of short-term triggers. The following additional profiles are recommended to be added to the existing monitoring program (also shown in Figure 10.1):

- a. Two (2) additional beach profiles MB-01 A & B in front of the Big 4
 Middleton Beach Caravan Park (MB-01 A Easting 583552.7m, Northing 6124094m & MB-01 B Easting 583580., Northing E 6124321.1m).

- b. Relocation of MB-05 profile south to be directly in front of Griffiths Street (Easting 584926.0m, Northing 6125965.8m).
 - c. One (1) additional profile MB-10 at the southern end of the Emu Point revetment (Easting 585777m, Northing 6126430m).
