BUILT SPECIFICATION

Specifications for Built Structures Digital Spatial Data at the City of Albany

Version 1.3 2019

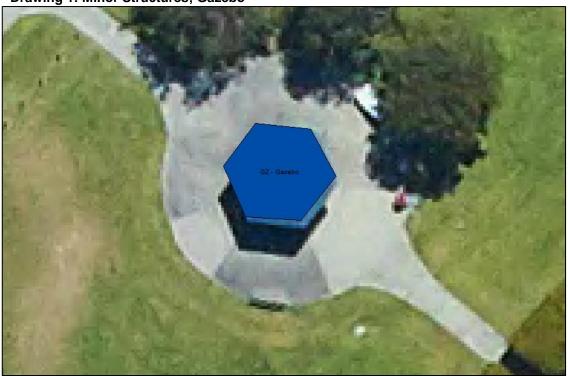
Drawing 1: Minor Structures; Gazebo

The perimeters of smaller uninhabitable structures used for sheltering signs, electrics, pumps. Or a public amenity like a memorial gazebo or seating shelter. It includes hard stands or concrete, verandas and patios that are associated with a licenced building. Hard stands isolated in parks or open areas are recorded in the Managed Space Specification.

Each extent shall be depicted by a single polygon (Shown as black polygons in <u>Drawing 1</u>).

These polygons are not to be "extracted/cut out" of the park area as this will affect area calculation.

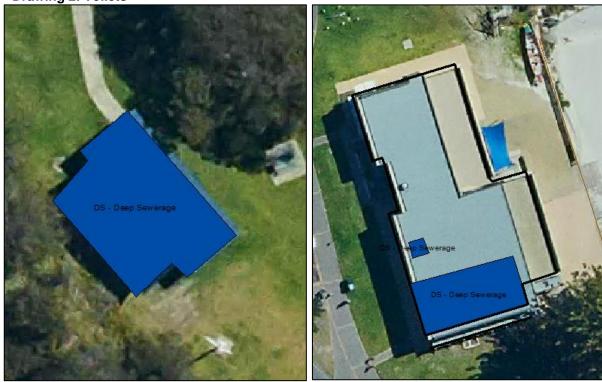
Drawing 2: Toilets

The perimeters of Public Toilets and shower facilities. This layer also includes non-public facilities maintained by the City of Albany.

Each extent shall be depicted by a single polygon (Shown in <u>Drawing 2</u>).

These polygons are not to be "extracted/cut out" of the park area as this will affect the area calculation.

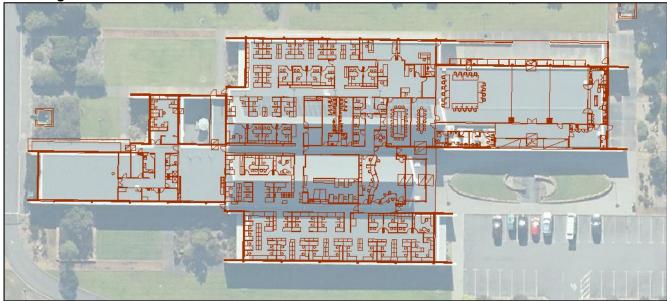
The floor and wall layout of facilities maintained by the City of Albany. It includes additional features like workstation desks and chairs.

These features shall be depicted by multiple polylines. Objects like chairs, desks and walls can be merged into multi-polyline features as one record.
