DEVELOPMENT AND INFRASTRUCTURE SERVICES COMMITTEE MEETING

R1782 Rev 1

City of Albany

**Whalers Beach Public Infrastructure
Coastal Hazard Risk Management & Adaptation
Plan**

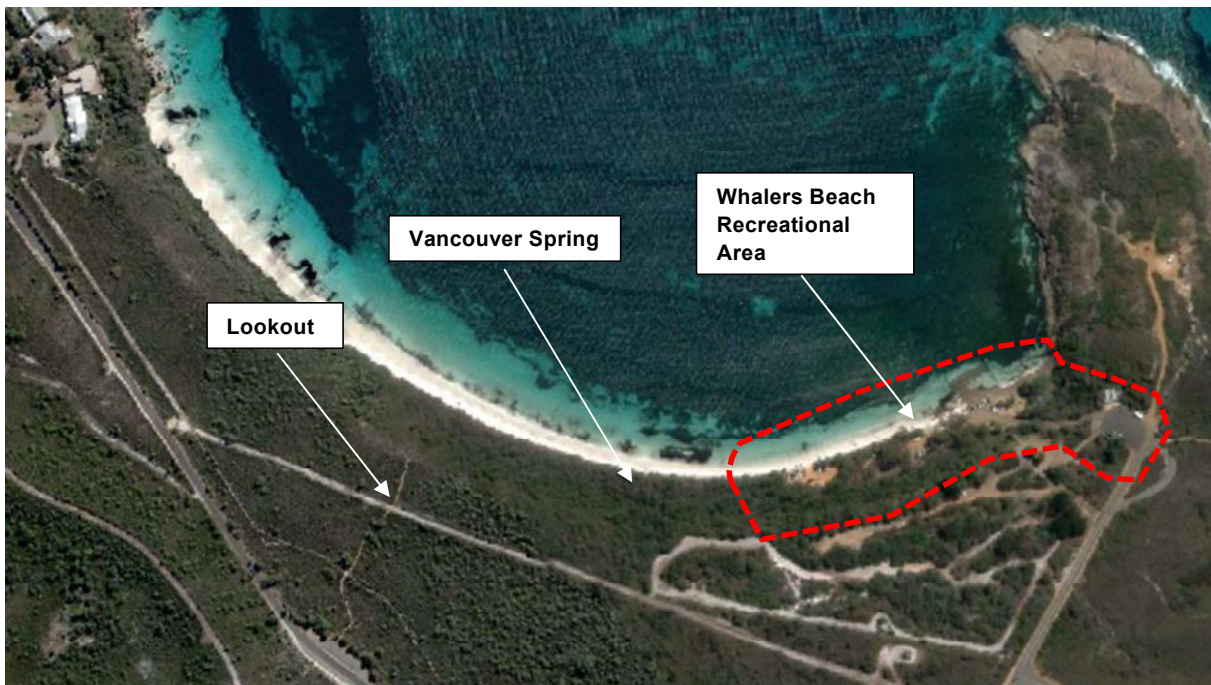
Figure 2.2 Public Assets within the Whalers Beach Area

Key assets within the study area and surrounds have been summarised in Table 2.1 and their location shown in Figures 2.2 and 2.3. The risk assessment will focus on these assets to identify their vulnerability and consequently the requirement for risk management. These assets have been broken down into their key components and further refinement would not be beneficial to the CHRMAP. For this type of assessment, it is the vulnerability of the overall assets that is the important factor.

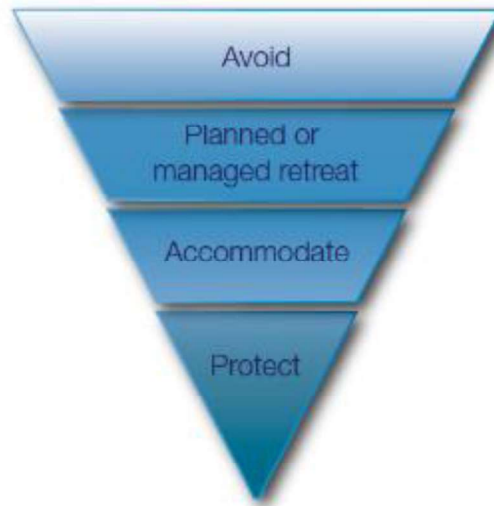
Figure 7.1 Risk Management & Adaptation Hierarchy

Risk adaptation and mitigation strategies are required for the city to address the coastal hazard risks and asset vulnerabilities identified in Sections 5 and 6. SPP2.6 outlines a hierarchy of risk adaptation and mitigation options, where options that allow for a wide range of future strategies are considered more favourably. This hierarchy of options is reproduced in Figure 7.1.

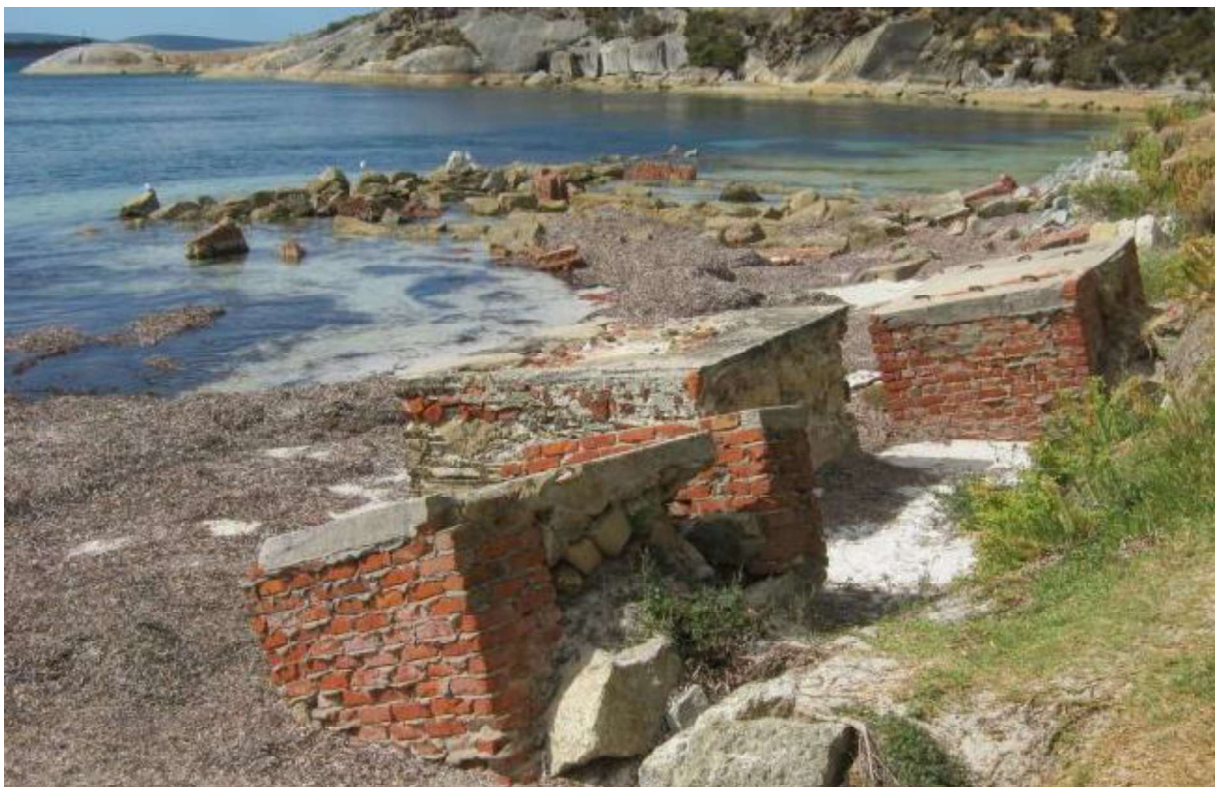
Figure 2.5 Remnant Material from the Norwegian Whaling Station (Frenchman Bay Association, 2021)

The Frenchman Bay Association (2021) provides a succinct summary of the history of the site. In particular, it is noted that following closure of the station the owners disassembled much of the machinery and relocated it to the site of their new facility at Point Cloates. However, it is noted that a large storm in 1921 wrecked the remaining slipway and loading jetty and eroded the seawall that protected the foundations of some buildings, causing them to topple. Whilst an amount of material was salvaged or removed, some of the material remained on site. An image of the remaining material is shown in Figure 2.5. This figure shows the remnants footings of some of the buildings as well as what is understood to be the remains of the initial seawall.

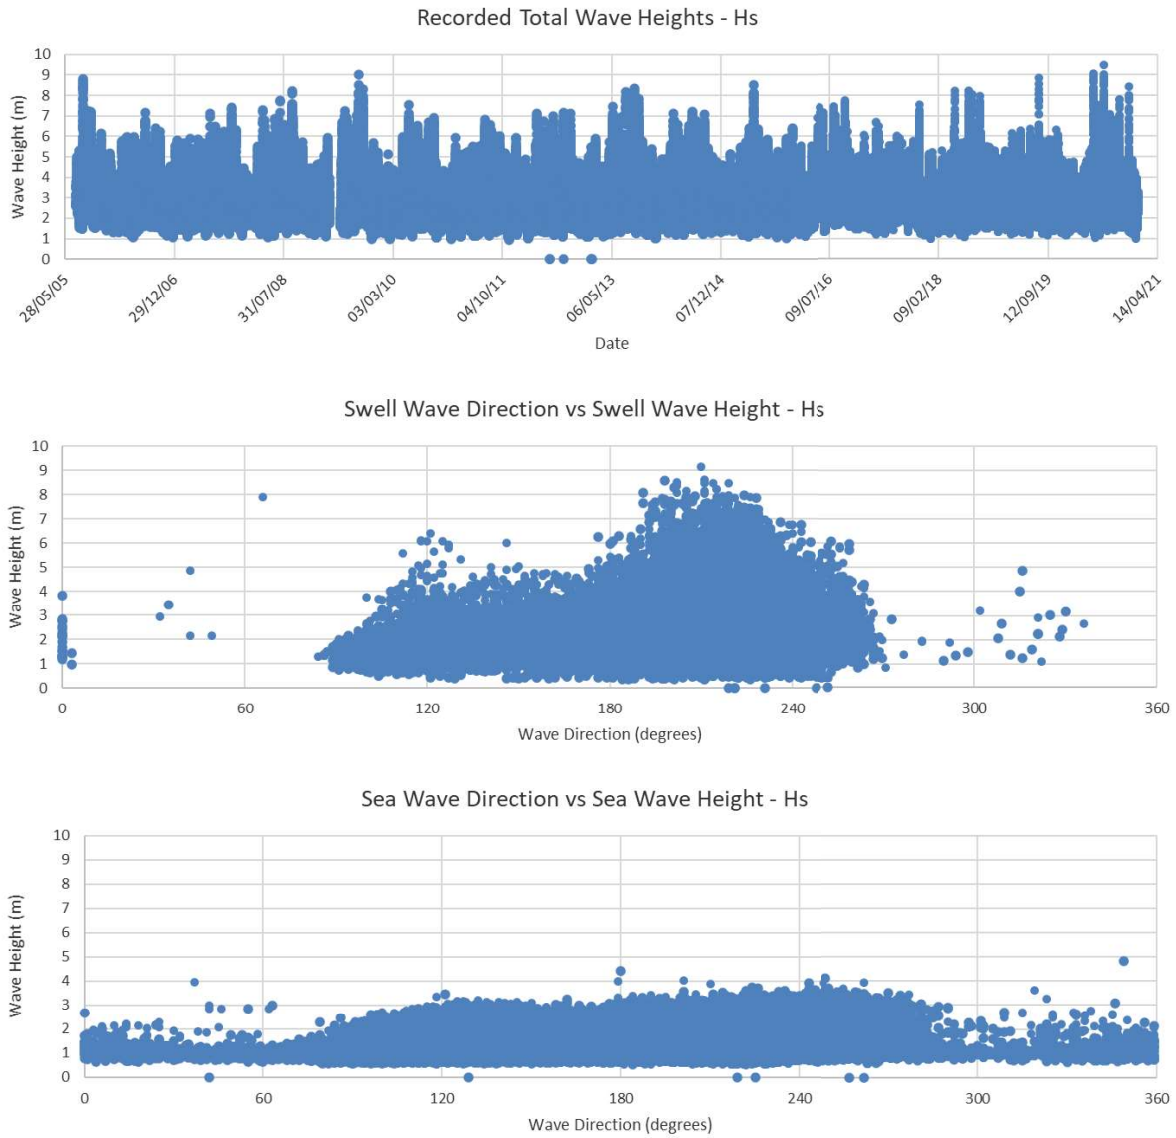
Figure 2.9 Wave Data Recorded from the Albany Waverider Buoy

Figure 2.9 shows that the most common direction for these offshore waves is from the southwest, but they also approach King George Sound from the south and occasionally the southeast. The severity of the wave heights also mirrors the persistence, with the most severe waves from the south through west. Interestingly, the plot of recorded wave heights shows that the winter of 2020 was relatively severe, with a cluster of higher wave heights than previously observed within the data record. This may explain some of the erosion pressures that have been experienced at Whalers Beach over the past couple of years.

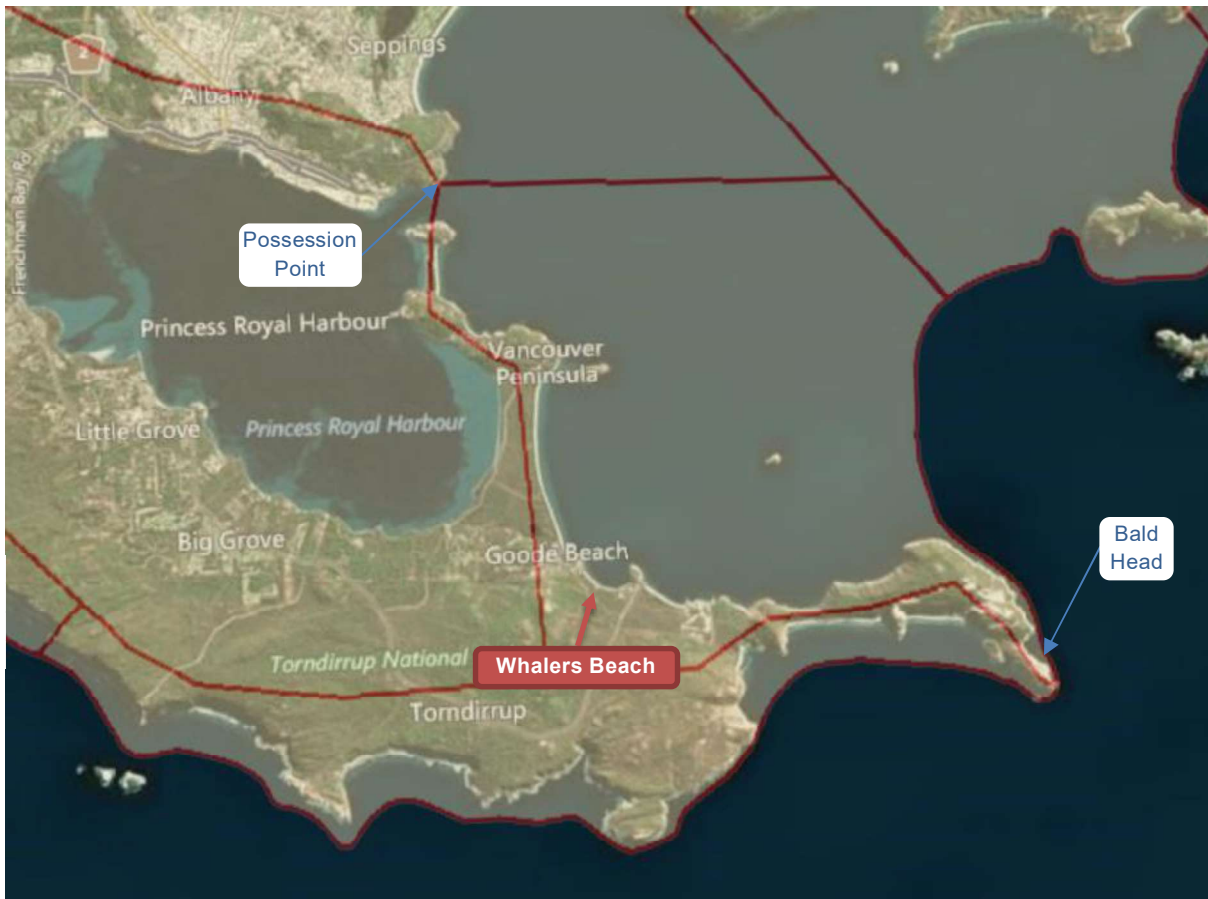
Figure 2.10 Extent of Coastal Sediment Cells

Over the planning horizons considered in this assessment (up to 100 years) Whalers Beach can be treated as a closed sediment cell. This is due to the fact that Vancouver and Waterbay Points essentially restrict sediment transport into or out of the Bay.

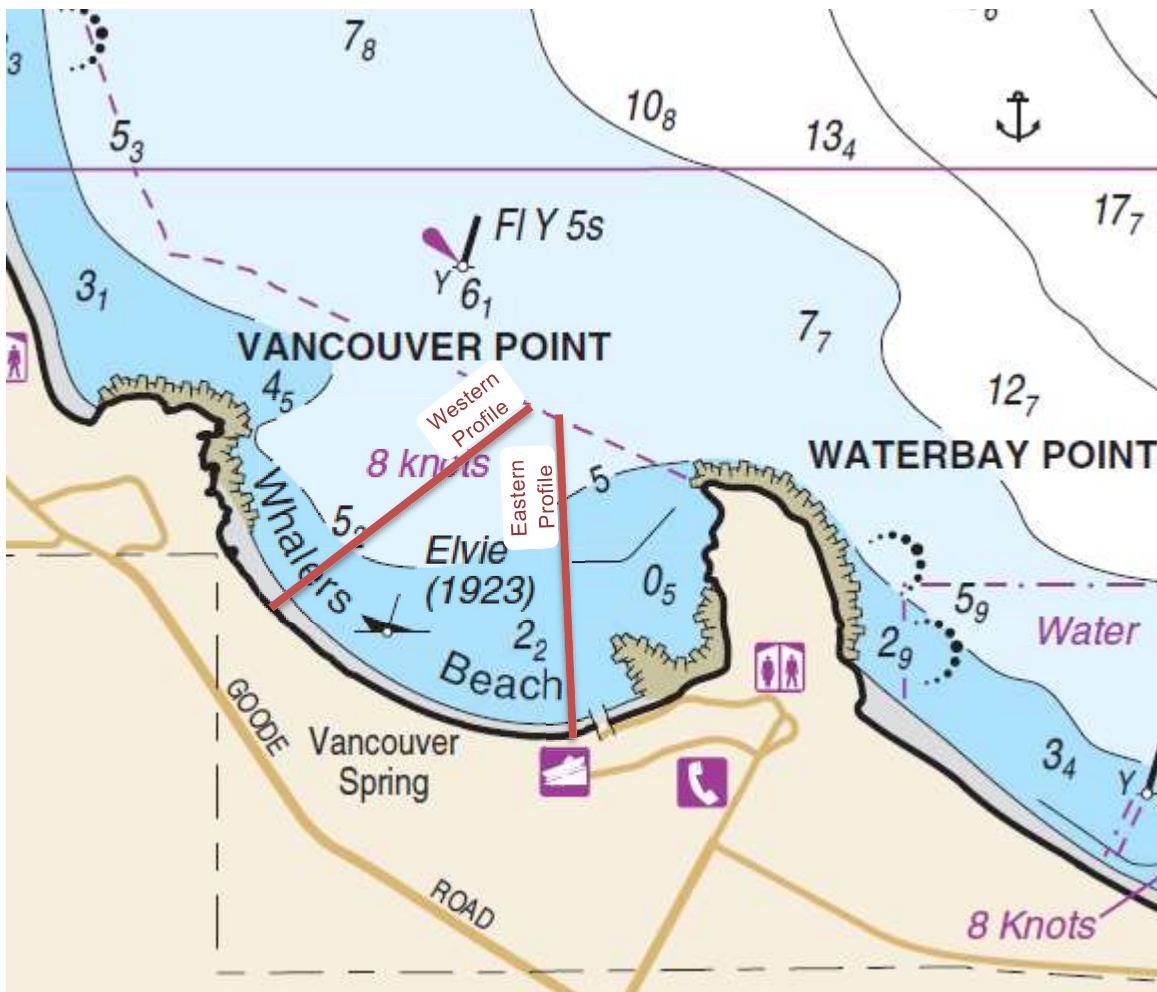
Figure 3.5 SBEACH Profile Location & Alignment

Given the change in aspect of Whalers Beach, two different beach profiles have been used to simulate the potential extent of severe storm erosion. The input beach profiles used in the modelling were taken from a combination of topographic survey data, hydrographic survey information and local nautical charts. The approximate location and alignment of the profiles are presented in Figure 3.5.

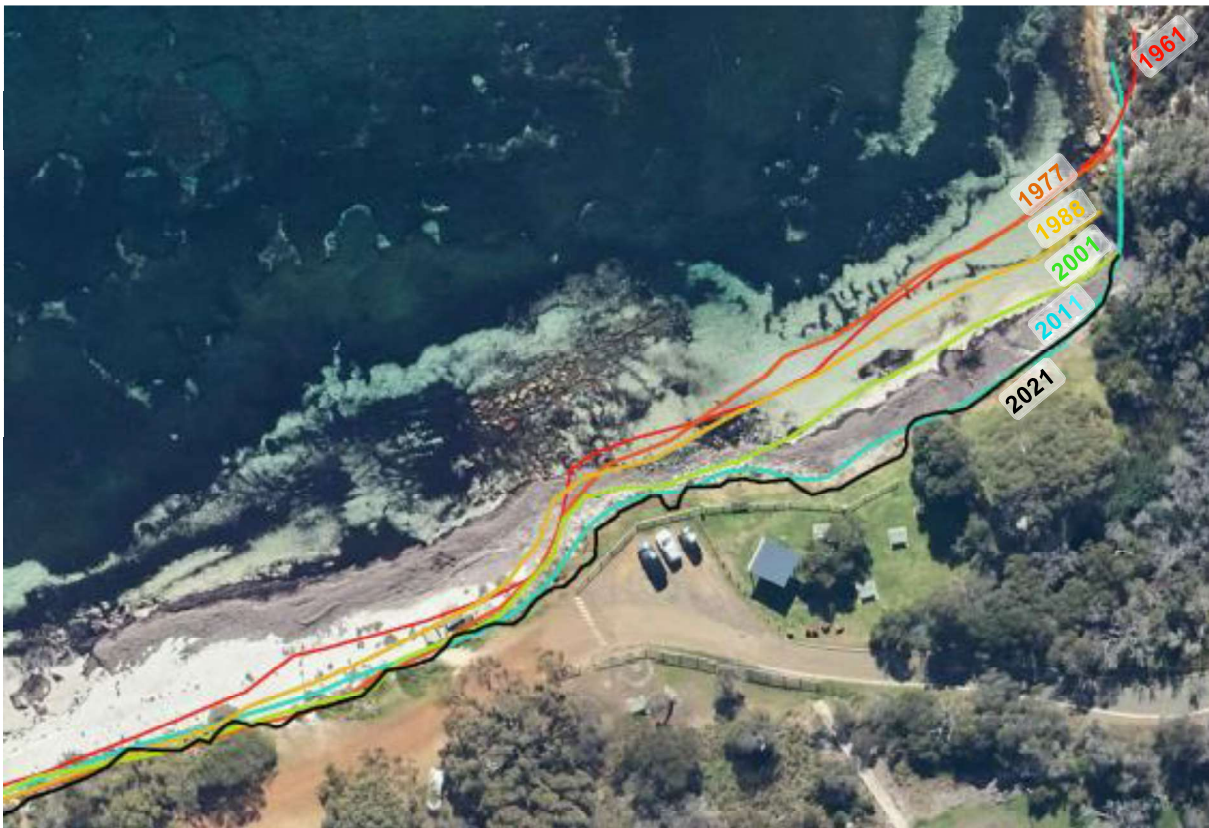
Figure 3.12 Shoreline Positions Adjacent to the Relic Seawall

Figure 3.12 shows a zoomed in view of a selection of mapped shoreline positions adjacent to the relic seawall. The figure shows an obvious disparity between the historical positions of the shoreline to the west and east of the structure. Note that this figure also includes a coastal vegetation line from 1961 which was mapped for this project but ultimately not used due to issues at the western end of Whalers Beach.

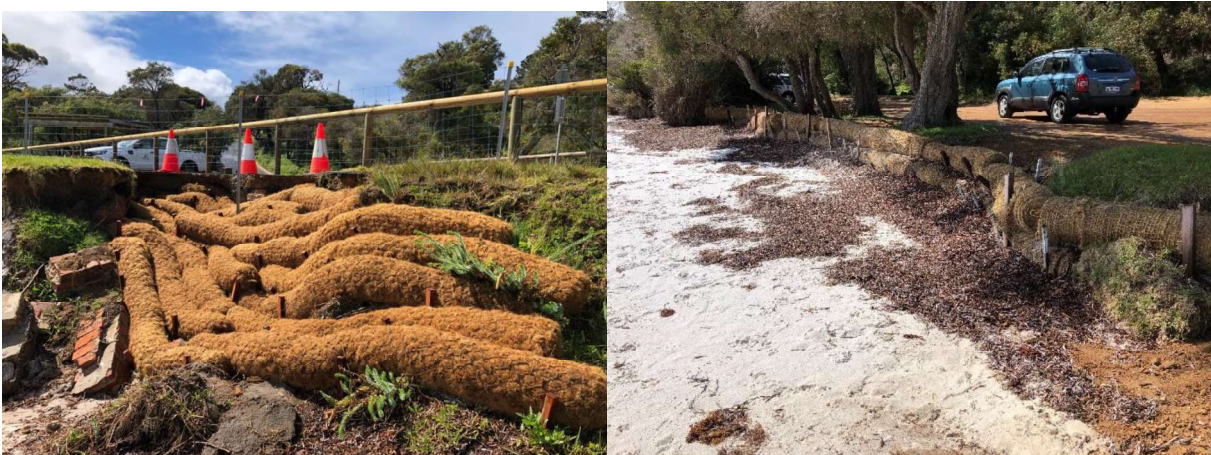
Figure 3.13 Coir Logs Installed by the City of Albany in 2021 to Combat Erosion

Regardless of the cause of the change to the seawall, and its associated level of shoreline control, it appears that the shoreline east and west of the structure are now better aligned and as a result, it is anticipated that chronic movement of the shoreline in this area would reduce in the future. Nevertheless, the fact that between 15 and 20 m of foreshore has been lost in this area means that the existing foreshore does not interface well with the adjoining beach. The absence of a dune system, or the mechanism for the natural formation of a dune system, in this area therefore further exacerbates the issue as it means that the foreshore is prone to impacts from severe storm erosion events and high water levels. This has been observed over the winter of 2021, with the City of Albany installing coir logs (refer Figure 3.13) to try and combat erosion of the foreshore area.

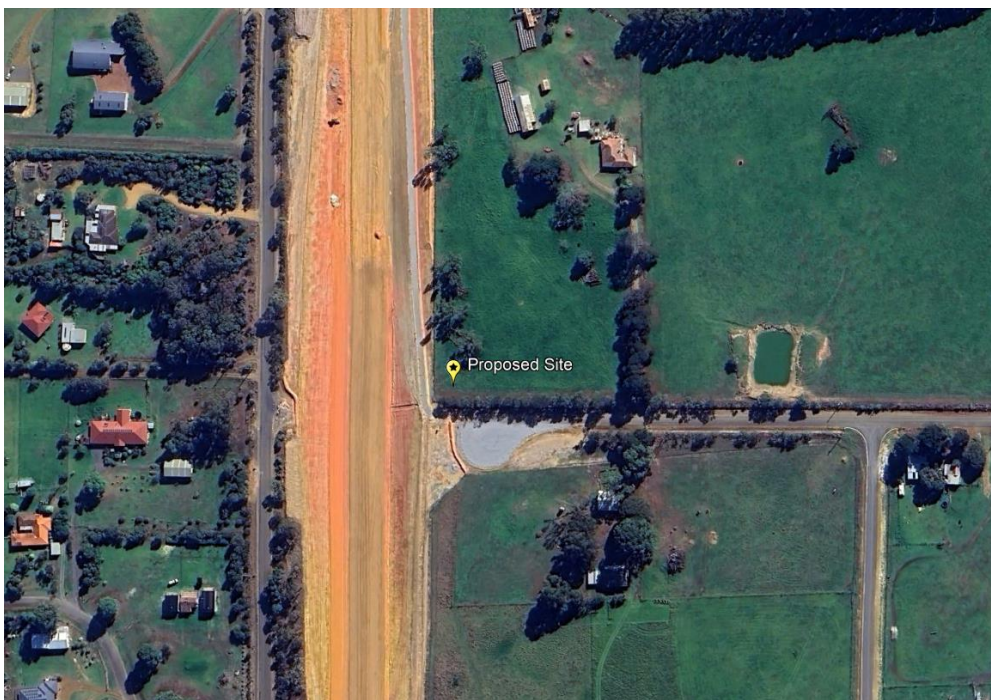
Figure 3: Site location. (Source: Google Earth)

The proposed facility is located in the south western corner of the subject property on an existing cleared area of land adjacent to the intersection of Lancaster Road and the new Albany Ring Road. The facility location is surrounded by mature vegetation along the property driveway and southern boundary. The site is located approximately 105m north west from the nearest residential dwelling and there are no sensitive uses within the immediate area. None of the existing vegetation is proposed for removal as part of the proposal.
